REPORT NUMBER 214-GTL-04-003

**SAFETY COMPLIANCE TESTING FOR  
FMVSS NO. 214S  
SIDE IMPACT PROTECTION (STATIC)**

**GENERAL MOTORS CORP.  
2004 CHEVROLET MALIBU, PASSENGER CAR  
NHTSA NO. C40102**

**GENERAL TESTING LABORATORIES, INC.  
1623 LEEDSTOWN ROAD  
COLONIAL BEACH, VIRGINIA 22443**

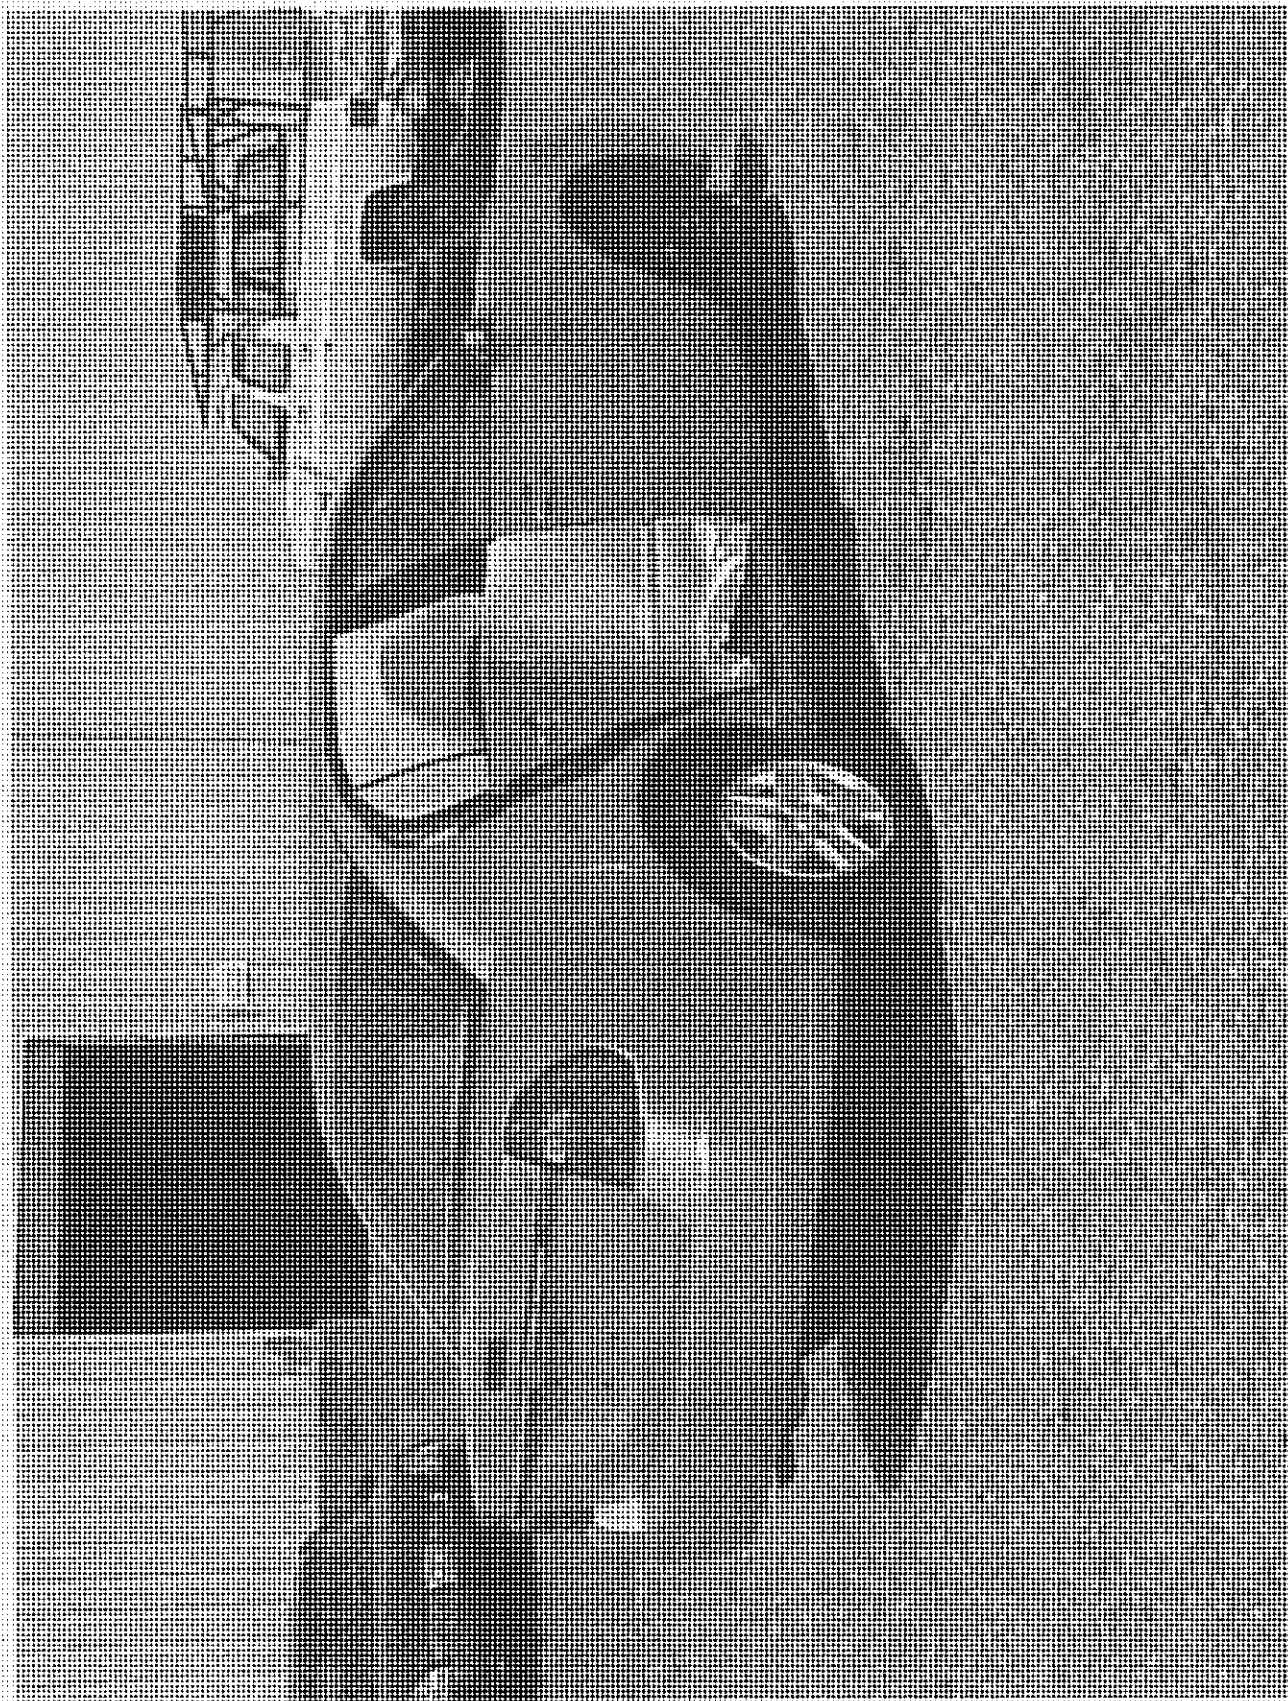
FIGURE 5.35  
¾ REAR VIEW FROM RIGHT SIDE OF  
VEHICLE POST TEST

| SECTION | | PAGE |
|---|---|---|
| | 5.36 3/4 Rear View from Right Side of Vehicle Post Test | |

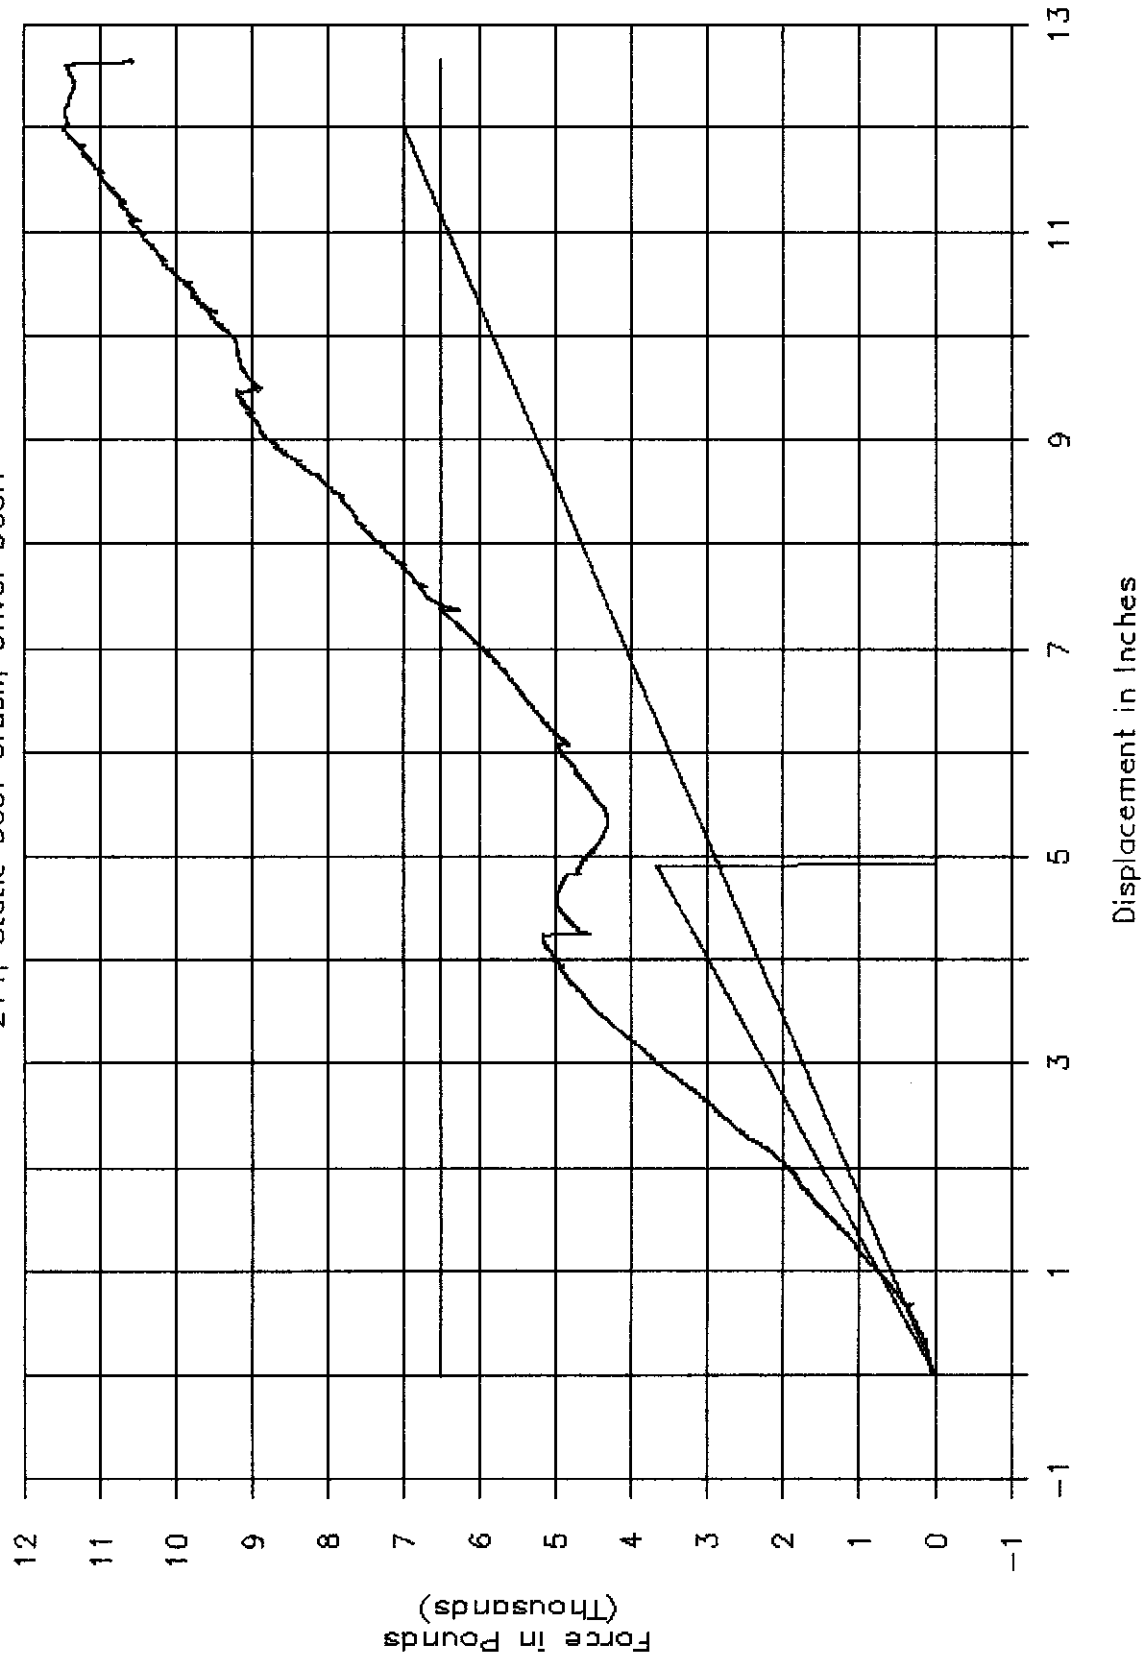
GTL 5246, NHTSA C40102.

214, Static Door Crush, Driver Door.

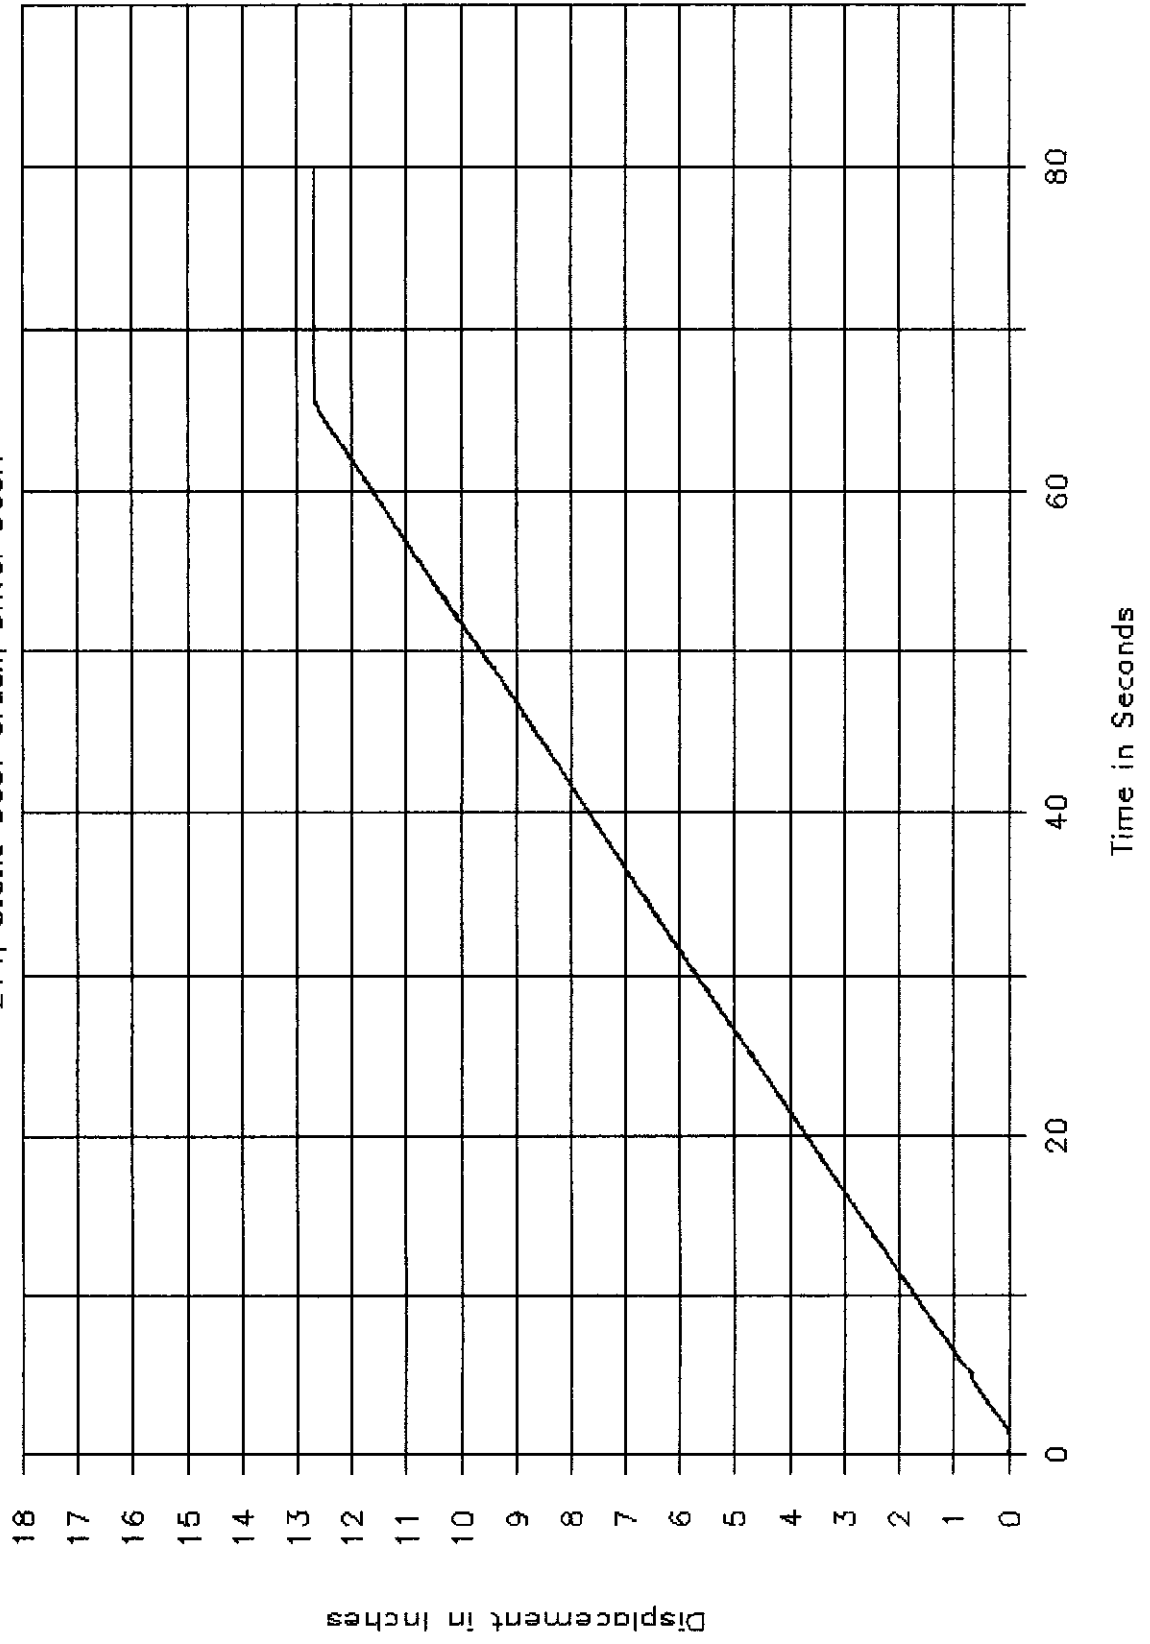
# GTL 5246, NHTSA C40102.

214, Static Door Crush, Driver Door.

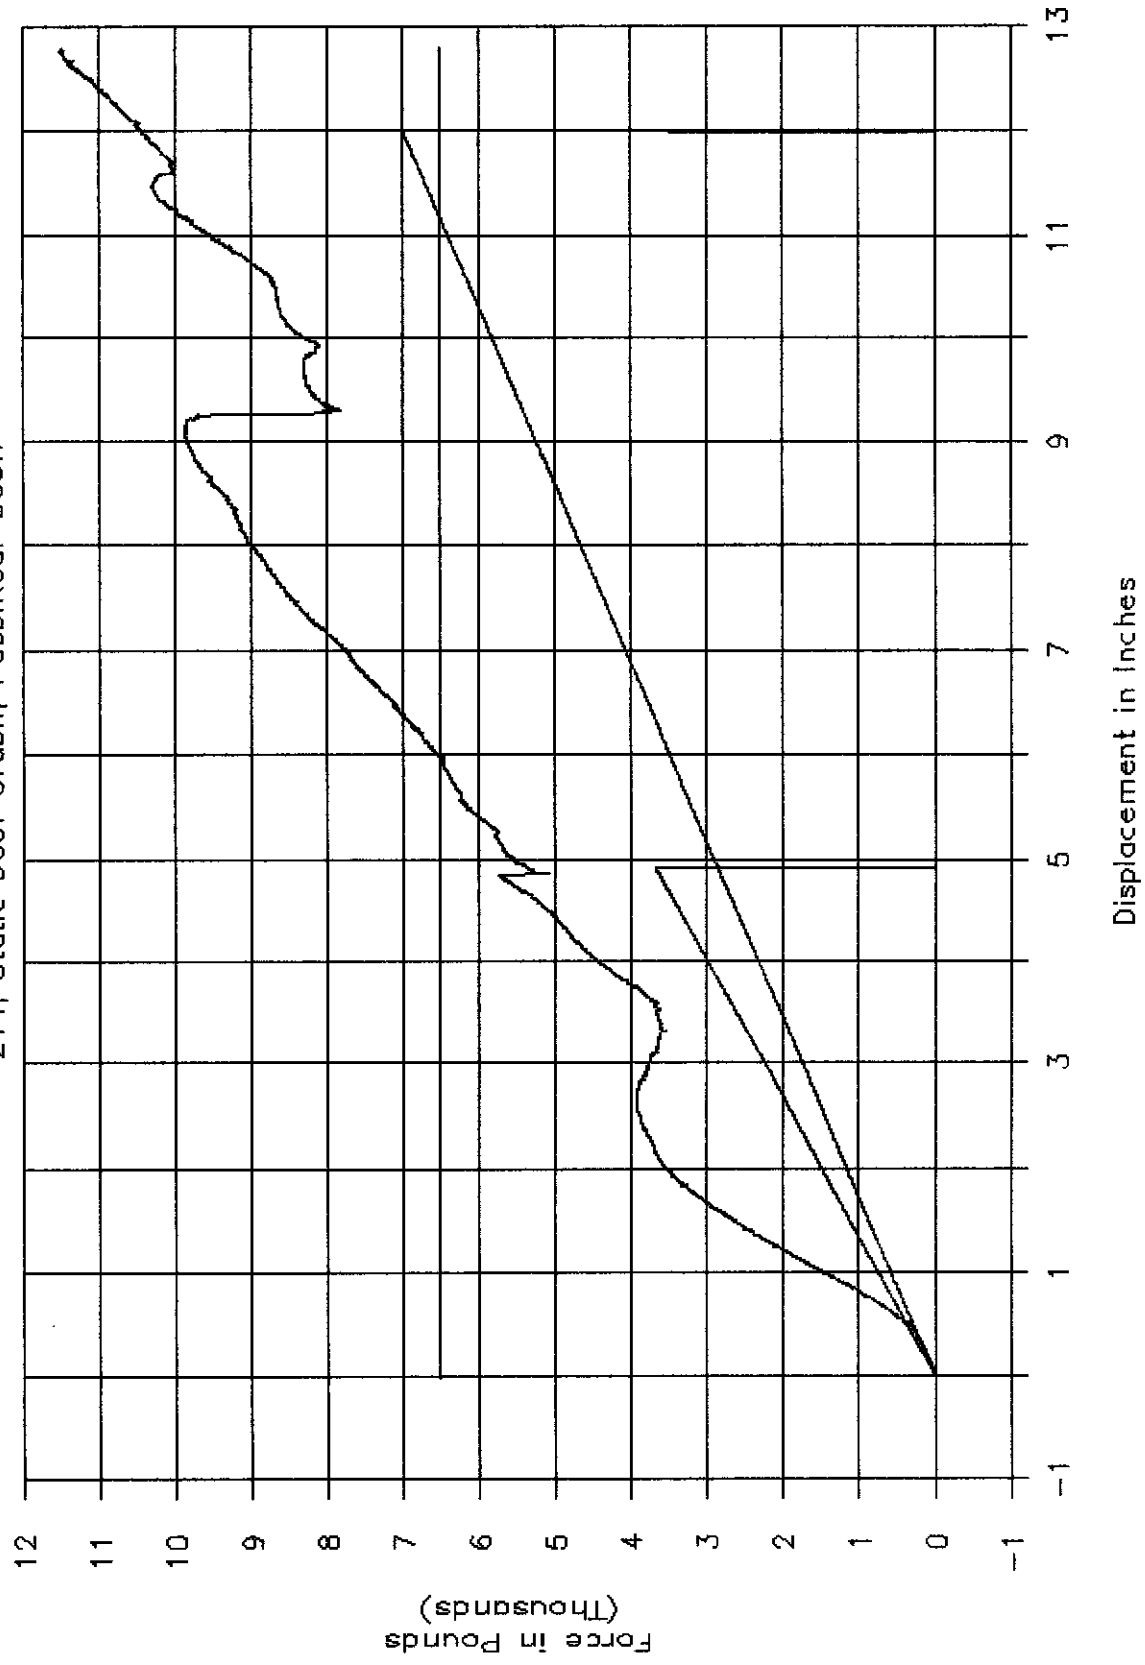
GTL 5247, NHTSA C40102.

214, Static Door Crush, Pass.Rear Door.

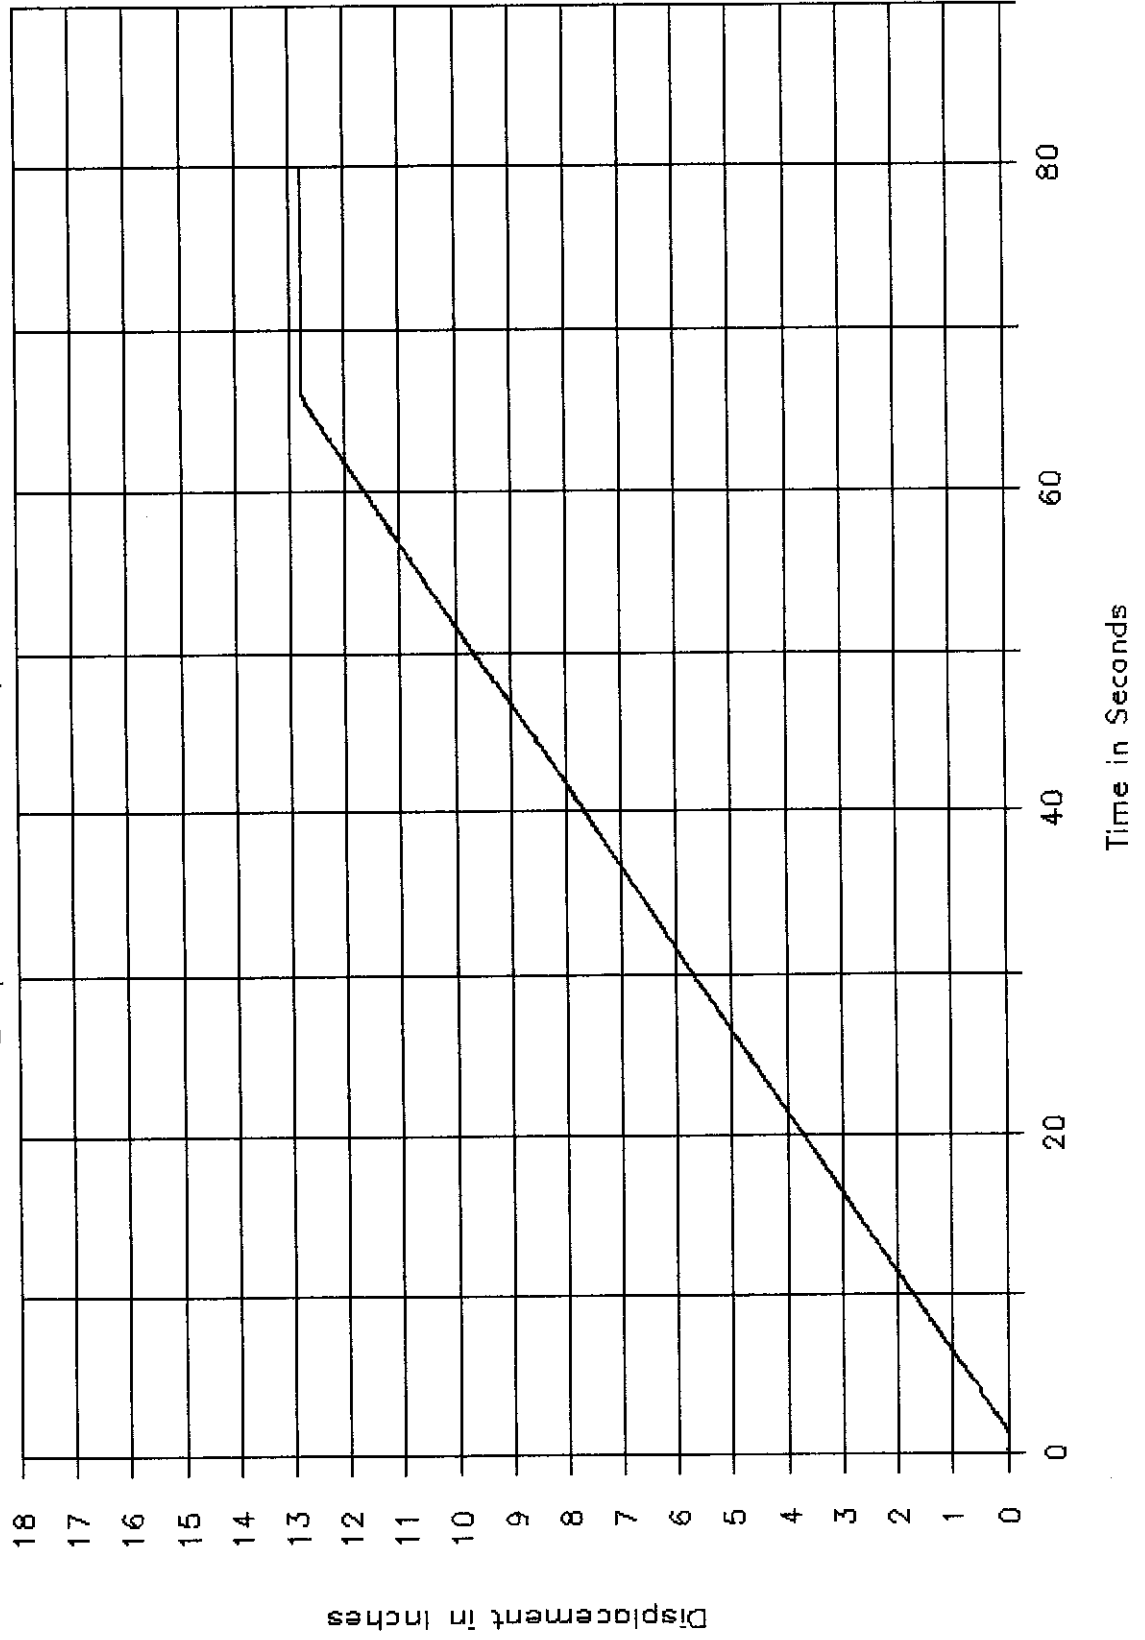
GTL 5247, NHTSA C40102.

214, Static Door Crush, Pass.Rear Door.
